2012-2013 CLP Survey Results

To: Beaver Dam Lake Management District (Board of Commissioners)
From: Barr Engineering Company (Meg Rattei)
Subject: June 2012 Curly-leaf Pondweed (CLP) Survey Results
Date: August 6, 2012
Project: 49030011.11
c: Kevin Kretsch, John Skogerboe, and Mark Sundeen

To: Beaver Dam Lake Management District (Board of Commissioners)
From: Barr Engineering Company (Meg Rattei)
Subject: 2013 CLP Treatment and Monitoring Results
Date: August 21, 2013
Project: 49030011.12
c: Kevin Kretsch (Lake Restoration, Inc.), Alex Smith (WDNR), Mark Sundeen (WDNR), and John Skogerboe (Research Scientist)

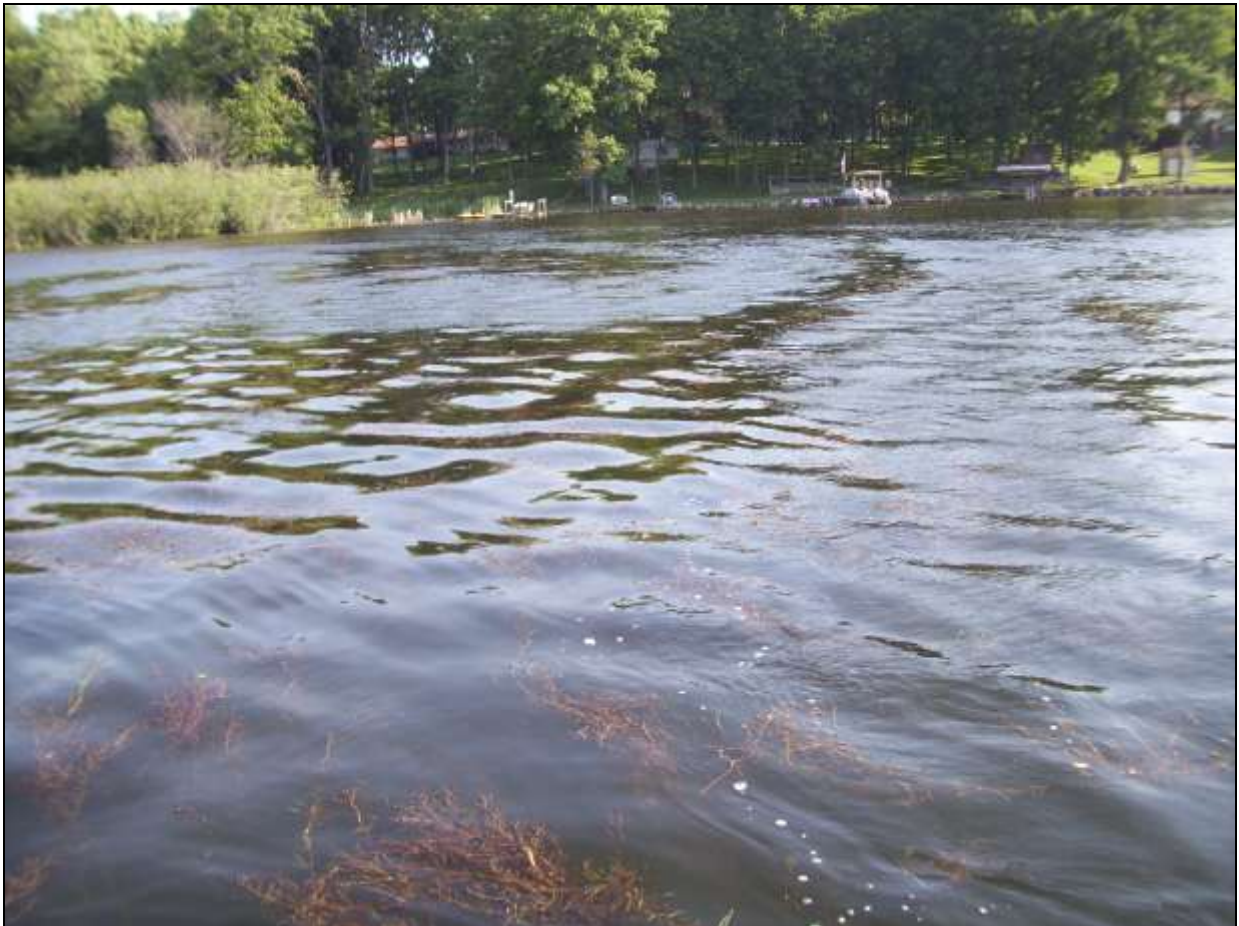
Figure 6 Canopied CLP bed on the North Side of City Bay

Three CLP beds were observed in City Bay (Figure 5). The CLP bed on the north side of City bay had been heavily impacted by boat traffic prior to the survey and plants were ripped up throughout the bay. Hence, it is likely that the CLP was denser in May. Plants were canopied (i.e., reached the surface of the water) throughout the bed in water less than 7 feet deep (Figure 6). Mean rake fullness at the time of the survey was only one to two, but CLP made up just over 50 percent of the total plant community in the majority of the area.

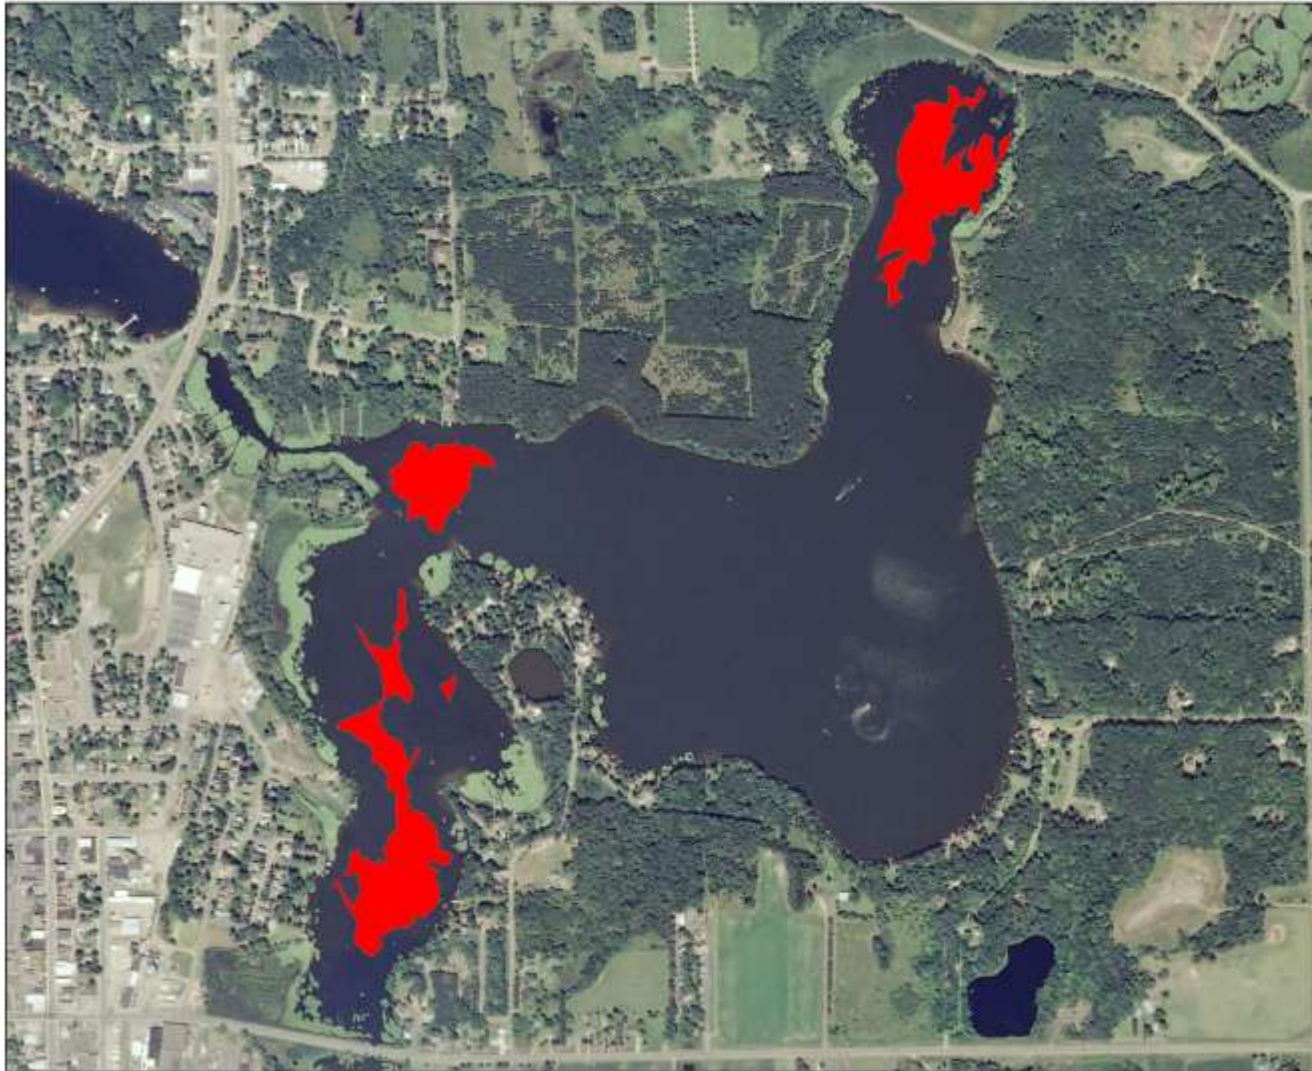
Figure 5 Norwegian Bay and City Bay CLP Beds

A large CLP bed occupied much of Norwegian Bay (Figure 5). CLP in Norwegian Bay was also highly fragmented with plants ending at the edge of the lily pads, and patches of native pondweeds, especially ribbon-leaf and variable pondweeds (*Potamogeton epihydrus* and *Potamogeton gramineus*) interspersed throughout. Similar to the large bed in City Bay, some areas of the Norwegian Bay CLP bed were 100 percent CLP and a solid rake fullness of three, patched into a mosaic of natives. Canopied CLP is pictured in Figure 9.

Treatment of Rabbit Island Bay channels and whole bay treatments of Norwegian Bay and City Bay with Endothall in the spring of 2013 is recommended. A June 2013 survey of the Rabbit Island Bay channels, Norwegian Bay, and City Bay is recommended to evaluate CLP treatment effectiveness.

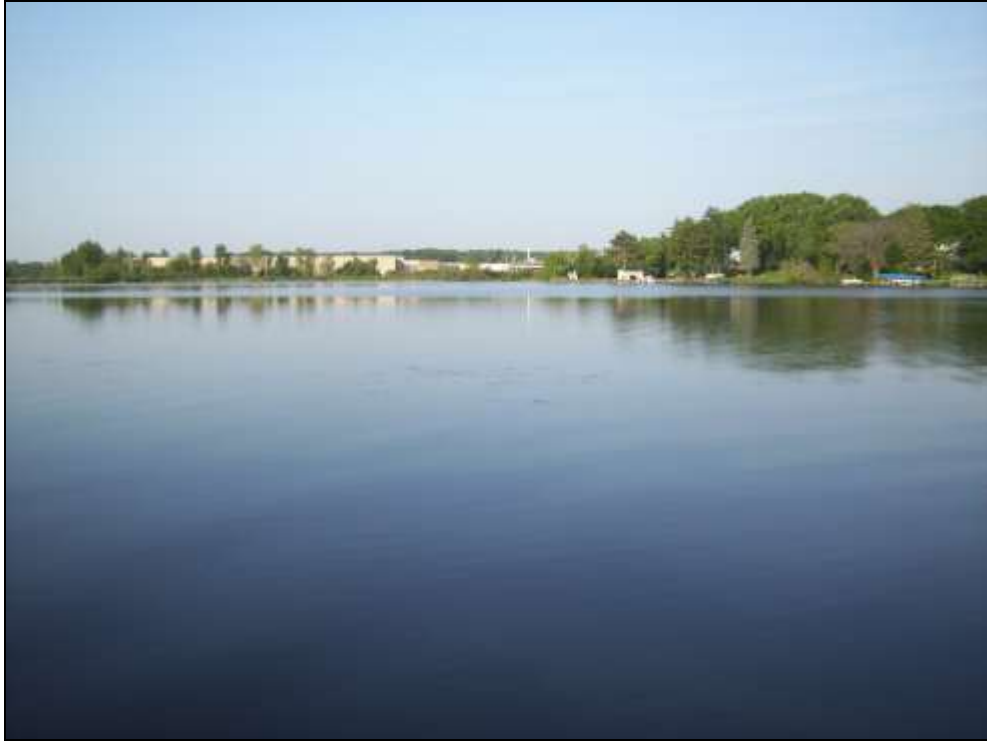
Figure 7 Canopied CLP in City Bay

The large CLP bed that occupied the central and southern parts of the bay noted a high density of CLP. CLP was canopied throughout, but it was very patchy. Some areas were 100 percent CLP and a solid rake fullness of three (i.e., maximum density per the 1 through 3 range of rake fullness used to determine density) (Figure 7). However, solid beds of natives were interspersed creating a mosaic (Figure 8). Areas vacated by CLP when it senesced in late June appeared to be quickly invaded by EMW in July.

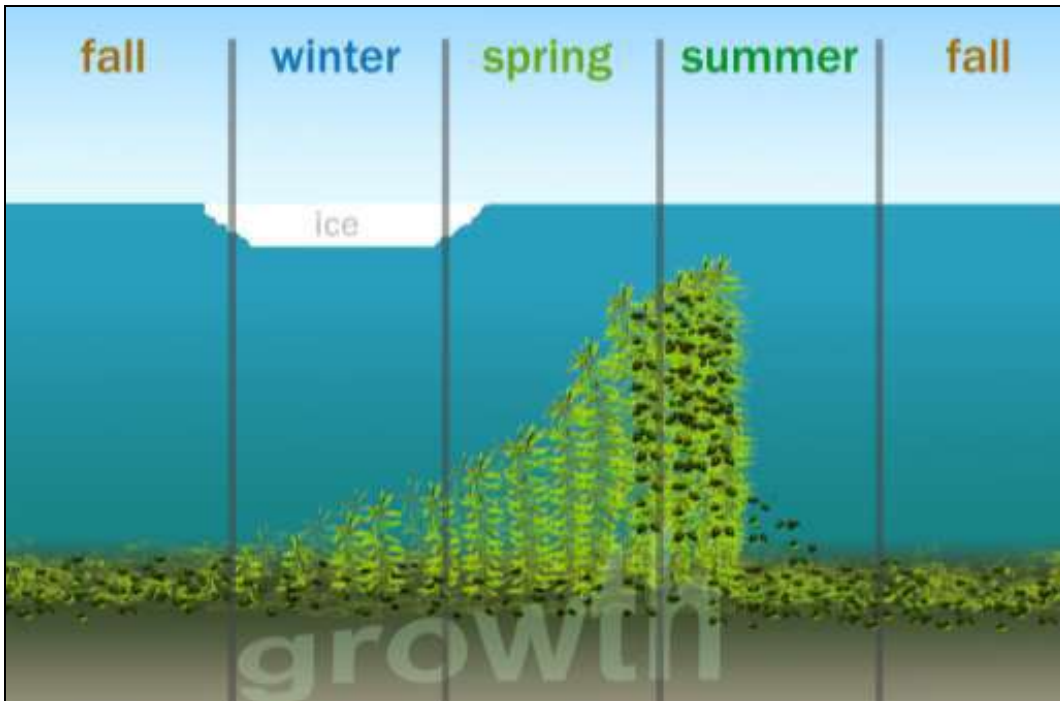
Figure 10 Curly-leaf Pondweed Growth Cycle

CLP treatment of Norwegian Bay and City Bay in the spring of 2013 is expected to not only contain CLP to a low occurrence, but also support the District's efforts to curtail the spread and proliferation of EWM. Because CLP dies off at the end of June (Figure 10), EWM has an opportunity to occupy areas vacated by CLP and spread rapidly during the June through July period. Plant surveys of Norwegian Bay and City Bay during June and July of 2012 documented the rapid spread of EWM following die-off of CLP (Table 2). Treatment of CLP in spring, before natives begin their growing season, will encourage the growth of natives rather than CLP. Because natives are present throughout the growing season, their presence would curtail EWM expansion since EWM would no longer have open areas vacated by CLP available for rapid expansion during the growing season.
