2011 Norwegian Bay Memo

Memorandum

To: Beaver Dam Lake Management District (Board of Commissioners)
From: Barr Engineering Company (Meg Rattei)
Subject: Norwegian Bay 2011 Plant Data
Date: August 5, 2011
Project: 49030011.08
c: Lake Restoration Inc. (Kevin Kretsch)

1.0 2008-2011 Herbicide Treatment Results from Norwegian Bay

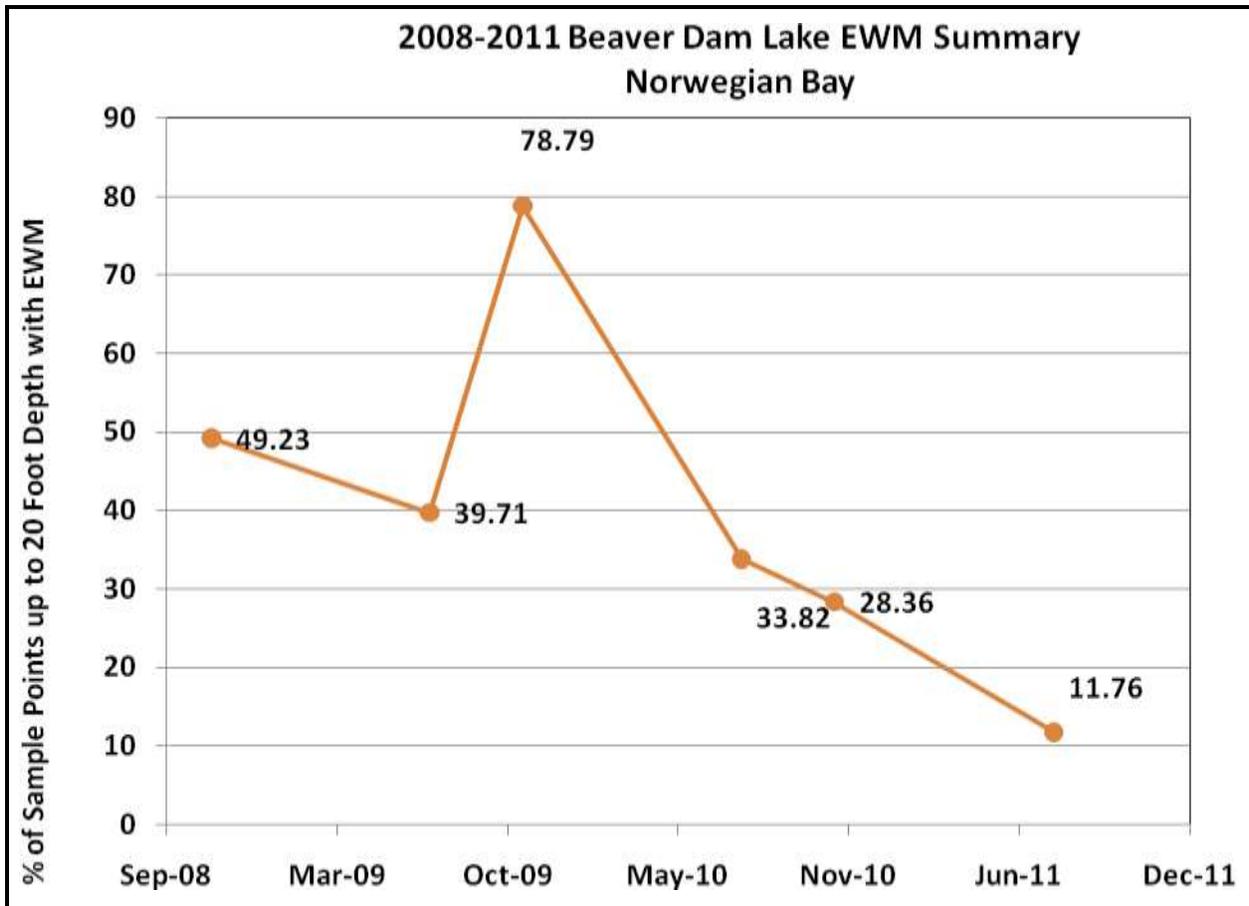
Figure 1 2008-2011 Beaver Dam Lake EWM Summary: Norwegian Bay

As shown in Figure 1, Eurasian watermilfoil in Norwegian Bay has declined substantially during the 2008 through 2011 period. In 2008, EWM was found in 48 percent of sample points up to the 20 foot depth. In 2009, EWM frequency increased to 79 percent of sample points up to the 20 foot depth. Since 2009, EWM has steadily declined. EWM frequency was 34 percent in the summer of 2010. A fall treatment in 2010 further reduced EWM frequency to 28 percent. A whole bay treatment in the spring of 2011 reduced the frequency to 12 percent in July of 2011. Hence, the 2011 treatment was effective.

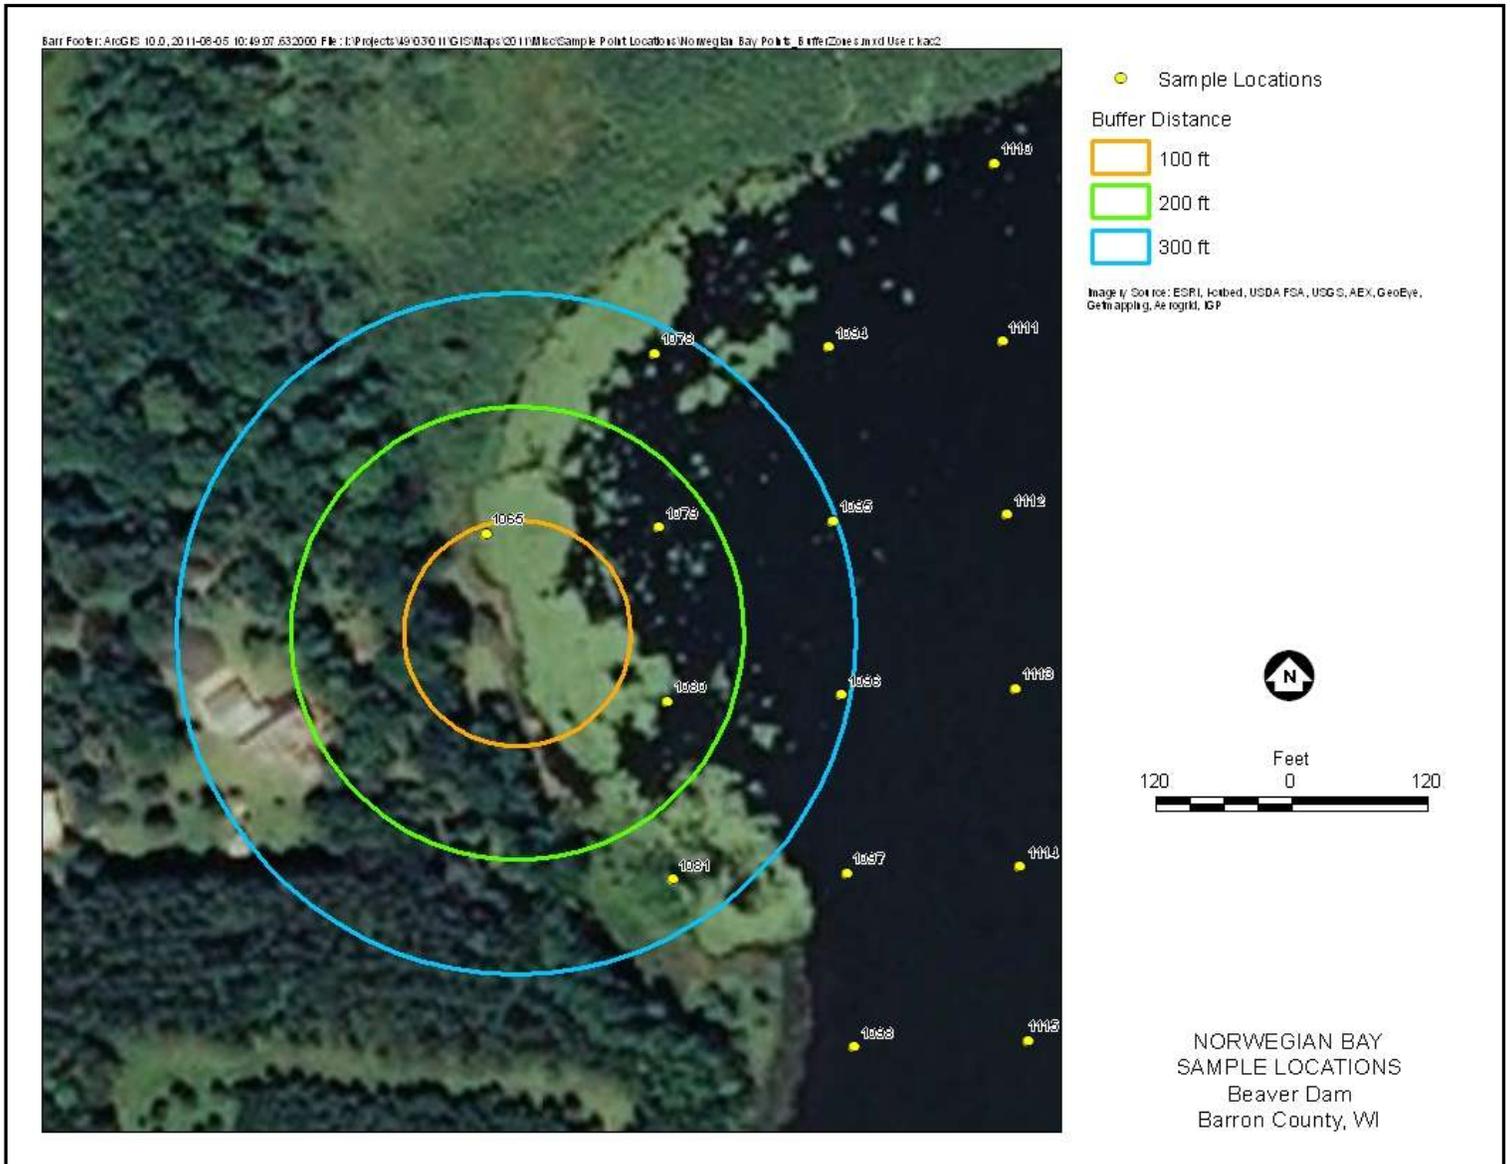
Figure 2. Norwegian Bay Sample Locations Adjacent to Tony Currella's Residence

One sample point, 1065, (Figure 2) was located within 100 feet of Tony's residence and a very dense growth of native species was observed at this sample point. The overall plant density at sample point 1065 was 3 on a scale of 1 to 3 with 3 being the maximum density rating. The most densely growing native species at sample point 1065 were common bladderwort and broad-leaved cattail, both noting a density of 3 or maximum density on the rating scale. Five additional native species were also found at this sample point – creeping bladderwort, water shield, small duckweed, large duckweed, and white water lily. EWM was not found at sample point 1065, only native species.

Two sample points were located within 100 to 200 feet of Tony's residence, 1079 and 1080 (Figure 2). EWM was not found at either sample point, but a total of 7 native species were found at each sample point. The non-native species curlyleaf pondweed was not collected on the rake at either sample point, but was visually observed at sample point 1080. The overall plant density at sample point 1080 was 3 or maximum density and the overall plant density at sample point 1079 was 2 on a scale of 1 to 3. Native species observed at sample point 1079 were watershield, Canada waterweed, water stargrass, Nitella, white waterlily, creeping bladderwort, and common bladderwort. Native species observed at sample point 1080 were Canada waterweed, water stargrass, slender naiad, white waterlily, small pondweed, creeping bladderwort, and small bladderwort.

Four sample points were located within 200 to 300 feet of Tony's residence, 1078, 1081, 1095, and 1096 (Figure 2). None of these sample points contained EWM in July of 2011. However, three of the four sample points noted an extremely dense growth of native vegetation.

The overall plant density at sample point 1078 (Figure 2) was 3 or maximum density. The most densely growing species was Canada waterweed that noted a density of 3 or maximum density. Five additional native species were observed at this location – watershield, water stargrass, white waterlily, white stem pondweed, and creeping bladderwort.

The overall plant density at sample point 1081 (Figure 2) was 3 or maximum density. The most densely growing species were swamp loosestrife and common bladderwort, both noted a density of 3 or maximum density. Six additional native species were observed at this location – Canada waterweed, small duckweed, white waterlily, large duckweed, creeping bladderwort, and small bladderwort.

The overall plant density at sample point 1095 (Figure 2) was 2 or medium density. Two native species were observed at this location – Canada waterweed with a density of 2 and nitella with a density of 1.

The overall plant density at sample point 1096 (Figure 2) was 3 or maximum density. The most densely growing species was Canada waterweed that noted a density of 3 or maximum density. Two additional native species were observed at this location – water stargrass and nitella.
